**Flood Control Project Maintenance
Levee Inspections**

Spring 2012 Levee Inspection Results

Reclamation District No. 1500 Sutter Basin

Levee Inspection Report By Mile - Spring 2012

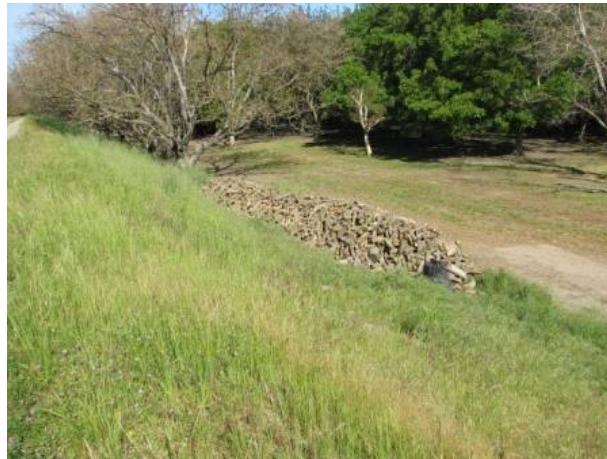
Levee Mile Report Line	4
Start Levee Mile	0.03
End Levee Mile	0.03
Location	Land Side
Category	Earthen Levee
Item	Encroachments
The firewood that was there last year has grown in size.	
johngw_s_20120313_362.jpg

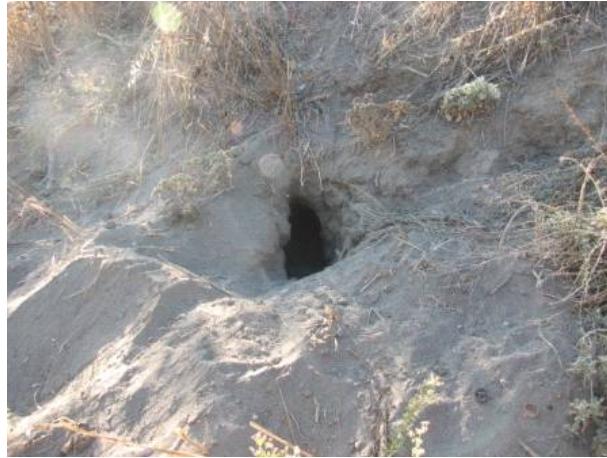
Levee Mile Report Line	5
Start Levee Mile	0.03
End Levee Mile	0.03
Location	Land Side
Category	Earthen Levee
Item	Animal Control
This is one of several rodent holes in the area.	
johngw_s_20120313_366.jpg

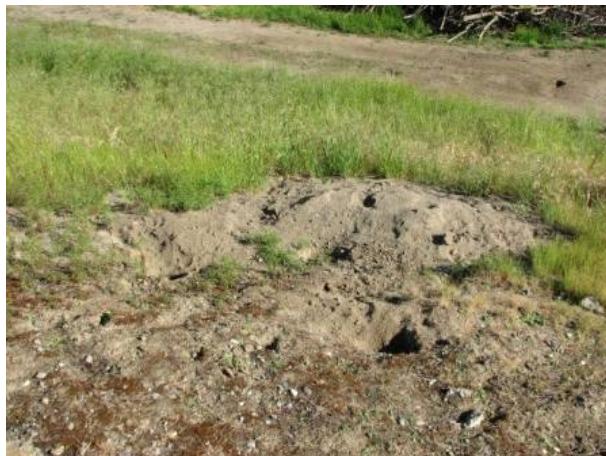
Levee Mile Report Line	5
Start Levee Mile	0.03
End Levee Mile	0.03
Location	Land Side
Category	Earthen Levee
Item	Animal Control
There are many rodent holes a short distance away from the last photo.	
john gw_s_20120313_368.jpg

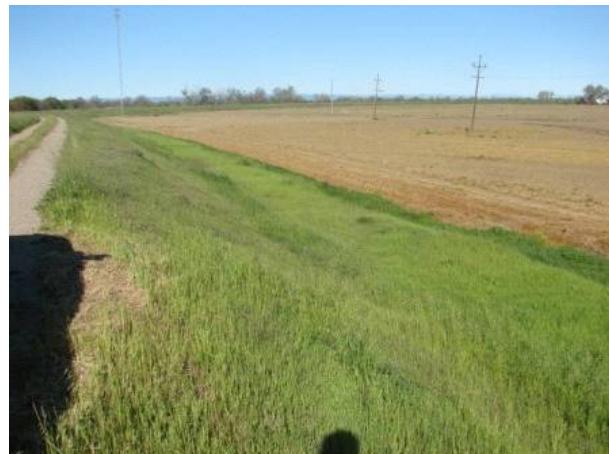
Levee Mile Report Line	17
Start Levee Mile	0.53
End Levee Mile	33.00
Location	Water Side
Category	Earthen Levee
Item	Vegetation
A view of the landside slope grasses taller than 12", photo taken spring 2012.	
johngw_s_20120409_662.jpg

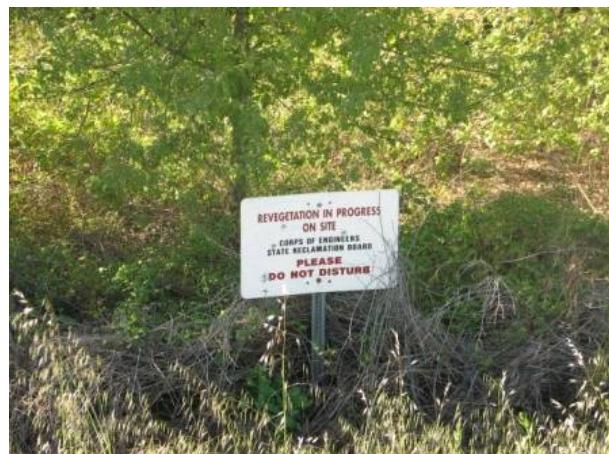
Levee Mile Report Line	18
Start Levee Mile	0.57
End Levee Mile	0.83
Location	Water Side
Category	Earthen Levee
Item	Vegetation
A revegetation site waterside toe, photo taken spring 2012.	
johngw_s_20120409_664.jpg

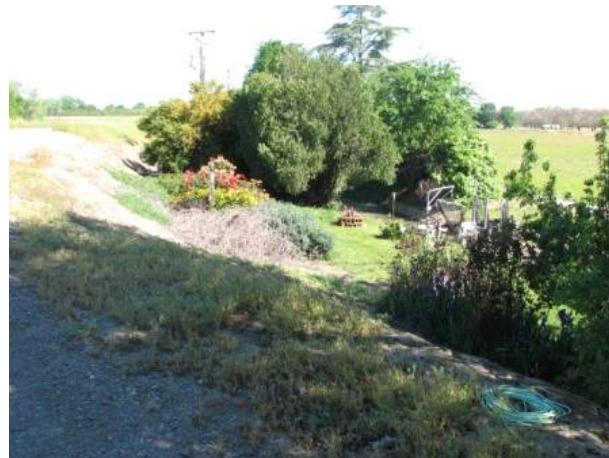
Levee Mile Report Line	28
Start Levee Mile	4.01
End Levee Mile	4.01
Location	Land Side
Category	Earthen Levee
Item	Vegetation
The landscape is planted into the encroachment zone within 15' of the toe.	
johngw_s_20120313_353.jpg

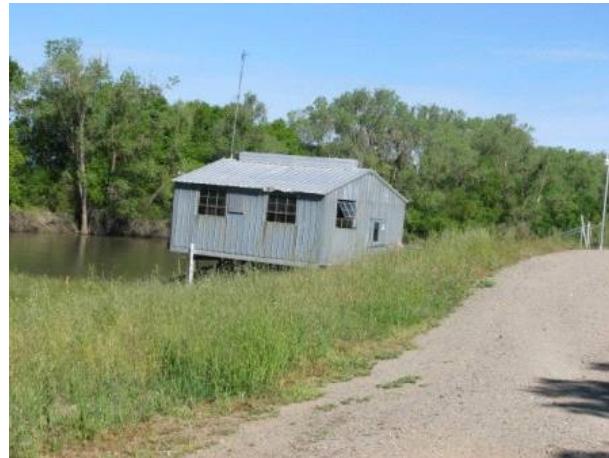
Levee Mile Report Line	29
Start Levee Mile	4.03
End Levee Mile	4.03
Location	Water Side
Category	Earthen Levee
Item	Encroachments
The building is the new pumping plant for Sutter Mutual Water. This replaces the abandoned one.	
johngw_s_20120313_354.jpg

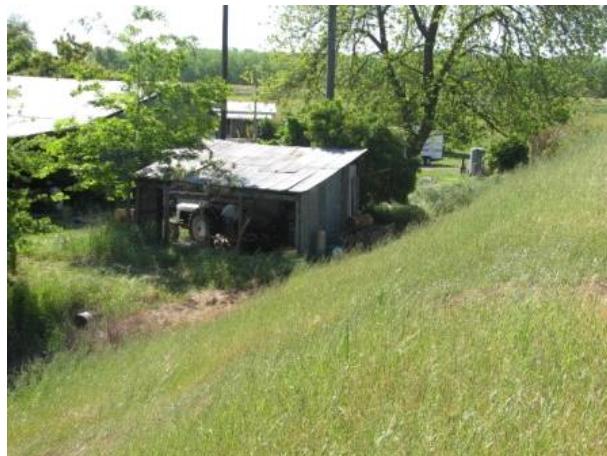
Levee Mile Report Line	31
Start Levee Mile	4.20
End Levee Mile	4.20
Location	Land Side
Category	Earthen Levee
Item	Encroachments
The equipment shed encroaches into the toe of the levee.	
johngw_s_20120313_358.jpg

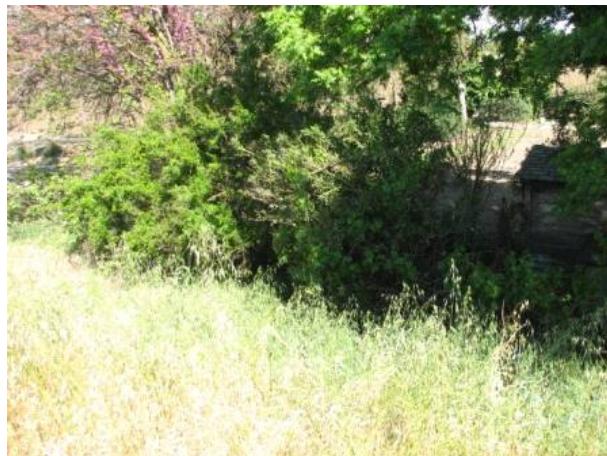
Levee Mile Report Line	32
Start Levee Mile	4.65
End Levee Mile	4.65
Location	Land Side
Category	Earthen Levee
Item	Vegetation
The landscape is planted within the encroachment area of 15'.	
johngw_s_20120313_359.jpg

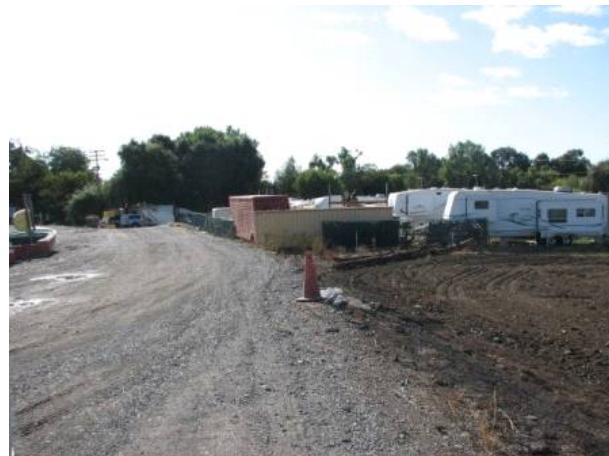
Levee Mile Report Line	35
Start Levee Mile	5.67
End Levee Mile	5.75
Location	Water Side
Category	Earthen Levee
Item	Encroachments
Another view of Stingrays RV park and entrance to the waterside business.	
johngw_s_20120313_408.jpg

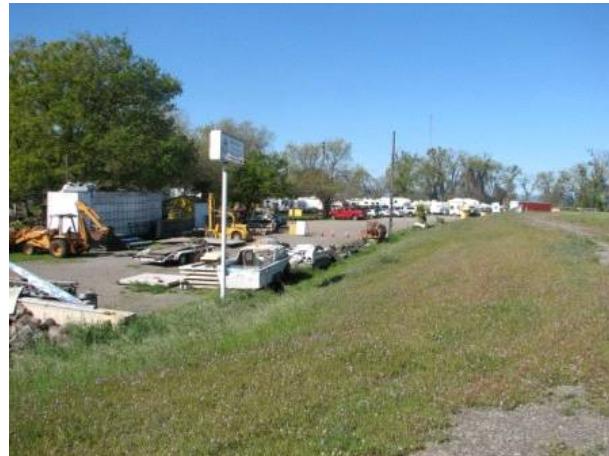
Levee Mile Report Line	35
Start Levee Mile	5.67
End Levee Mile	5.75
Location	Water Side
Category	Earthen Levee
Item	Encroachments
A current photo taken in the spring 2012.	
johngw_s_20120409_668.jpg

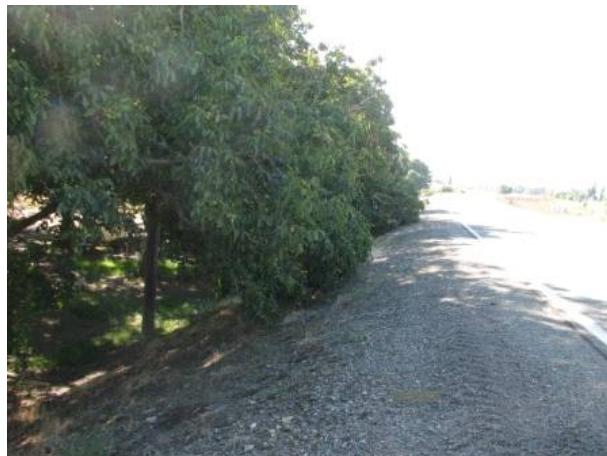
Levee Mile Report Line	37
Start Levee Mile	7.21
End Levee Mile	7.21
Location	Land Side
Category	Earthen Levee
Item	Trim / Thin Trees
Trees need to be trimmed to the height of 5 feet to see the slope.	
johngw_s_20120313_422.jpg

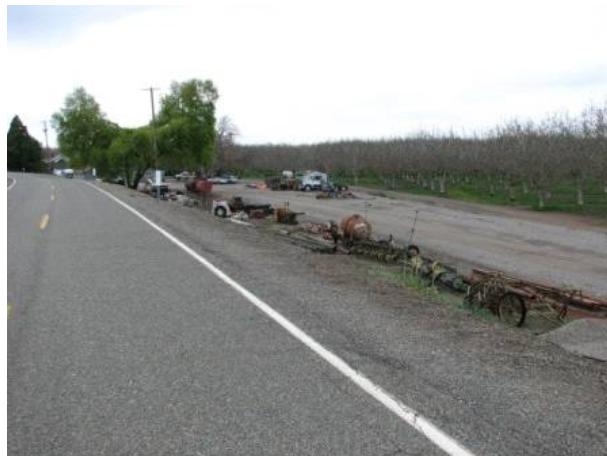
Levee Mile Report Line	38
Start Levee Mile	7.57
End Levee Mile	7.57
Location	Land Side
Category	Earthen Levee
Item	Encroachments
Equipment along landside toe. Photo was taken in spring 2010.	
johngw_s_20120313_363.jpg

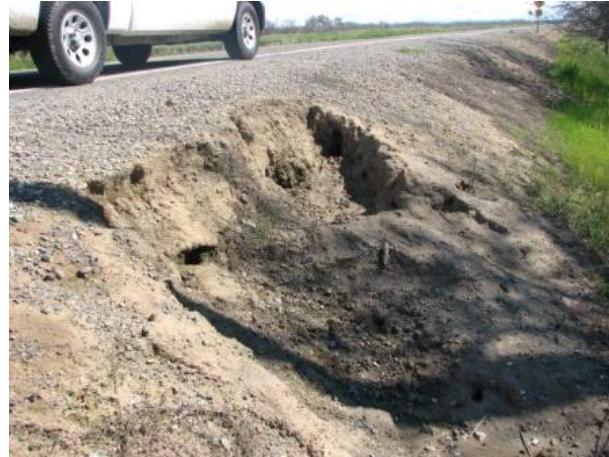
Levee Mile Report Line	41
Start Levee Mile	8.43
End Levee Mile	8.43
Location	Land Side
Category	Earthen Levee
Item	Erosion / Bank Caving

Erosion on the landside shoulder possibly caused by squirrels, photo taken spring 2012.

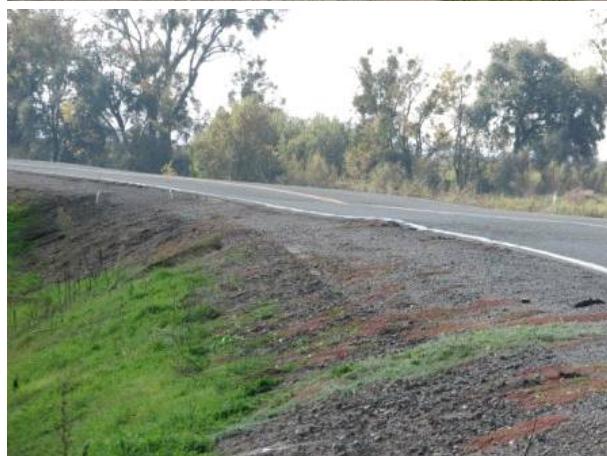
Levee Mile Report Line	44
Start Levee Mile	9.14
End Levee Mile	9.14
Location	Crown
Category	Earthen Levee
Item	Crown Surface / Depressions / Rutting
There is a depression in the county road that is on the crown. This has been an on going issue for years according to the district. Fall 2011	
johngw_s_20120313_425.jpg

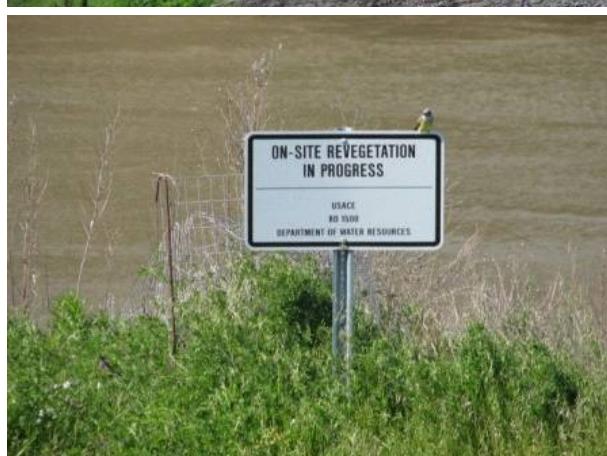
Levee Mile Report Line	45
Start Levee Mile	9.47
End Levee Mile	9.71
Location	Water Side
Category	Earthen Levee
Item	Vegetation
Another revegetation site photo taken spring 2012.	
johngw_s_20120409_670.jpg

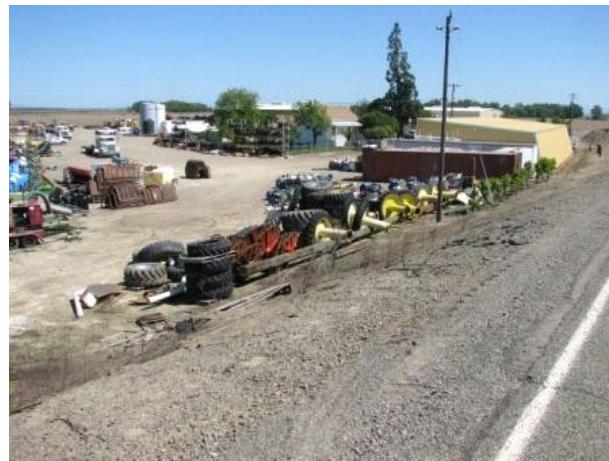
Levee Mile Report Line	58
Start Levee Mile	13.18
End Levee Mile	13.18
Location	Land Side
Category	Earthen Levee
Item	Encroachments
Next to the building there are tires and axles stored at the toe.	
johngw_s_20120313_434.jpg

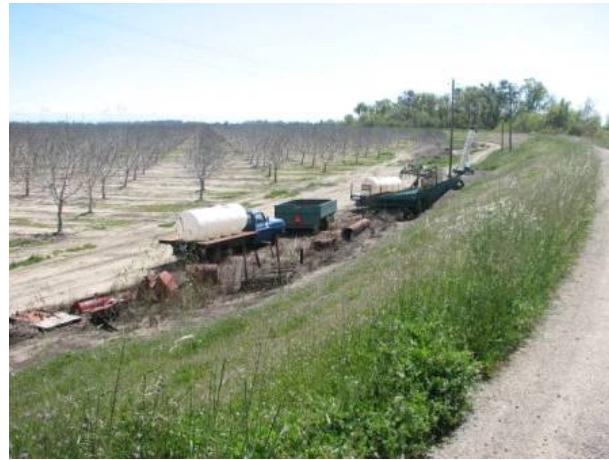
Levee Mile Report Line	70
Start Levee Mile	16.37
End Levee Mile	16.37
Location	Land Side
Category	Earthen Levee
Item	Encroachments
The equipment is parked along the toe of the levee, photo taken spring 2012.	
<i>johngw_s_20120409_677.jpg</i>

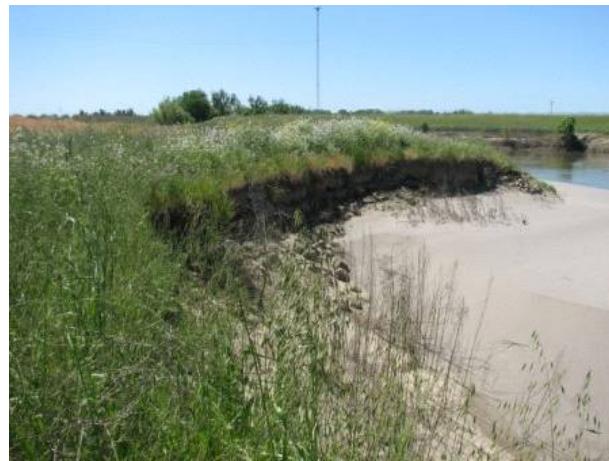
Levee Mile Report Line	75
Start Levee Mile	18.50
End Levee Mile	18.50
Location	Water Side
Category	Earthen Levee
Item	Erosion / Bank Caving
This is an inside curve in the river and erosion has occurred.	
johngw_s_20120313_404.jpg

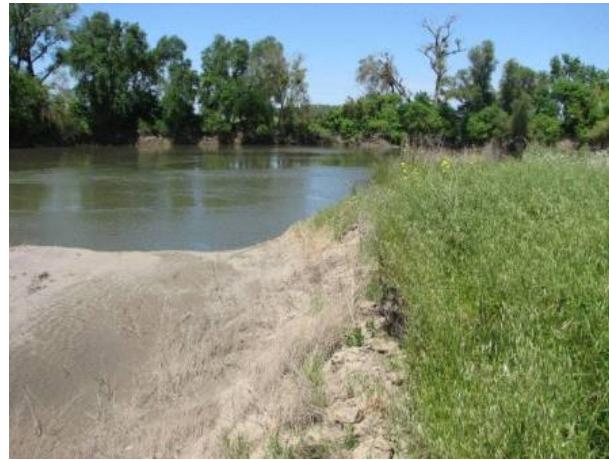
Levee Mile Report Line	75
Start Levee Mile	18.50
End Levee Mile	18.50
Location	Water Side
Category	Earthen Levee
Item	Erosion / Bank Caving
This is an upstream view of the same erosion.	
johngw_s_20120313_405.jpg

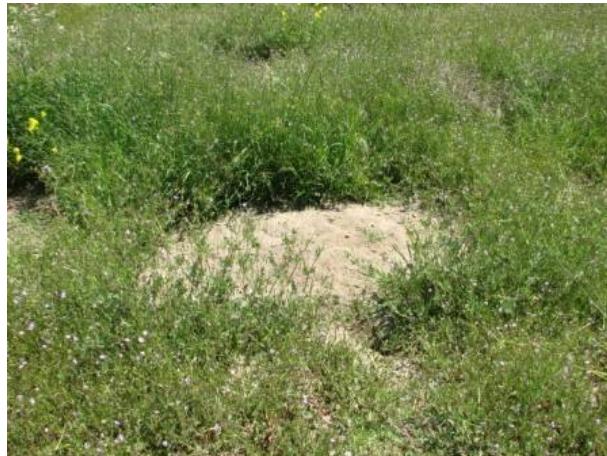
Levee Mile Report Line	83
Start Levee Mile	21.29
End Levee Mile	21.29
Location	Land Side
Category	Earthen Levee
Item	Animal Control
Rodent holes on the landside levee slope, photo taken spring 2012.	
<i>johngw_s_20120409_679.jpg</i>

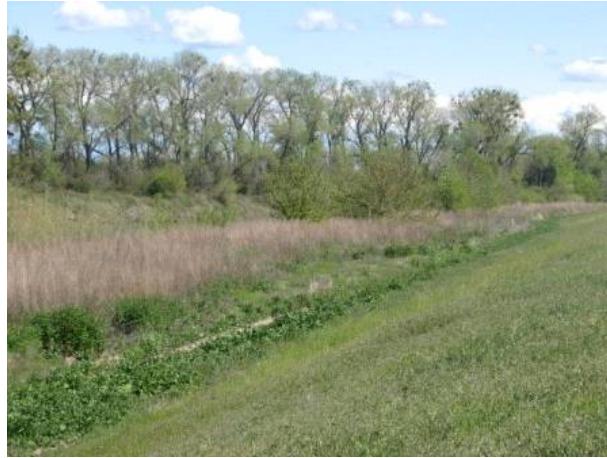
Levee Mile Report Line	97
Start Levee Mile	29.31
End Levee Mile	29.54
Location	Water Side
Category	Earthen Levee
Item	Vegetation
A photo of the revegetation site.	
johngw_s_20120409_682.jpg

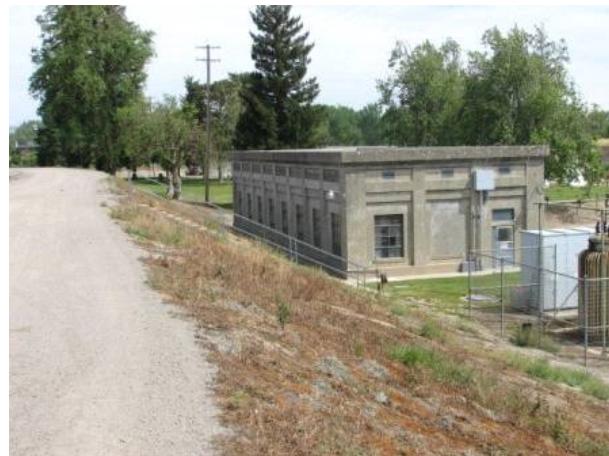
Levee Mile Report Line	108
Start Levee Mile	33.41
End Levee Mile	33.41
Location	Land Side
Category	Earthen Levee
Item	Encroachments
The building is the pumping plant for Sutter Municipal.	
johngw_s_20120313_398.jpg

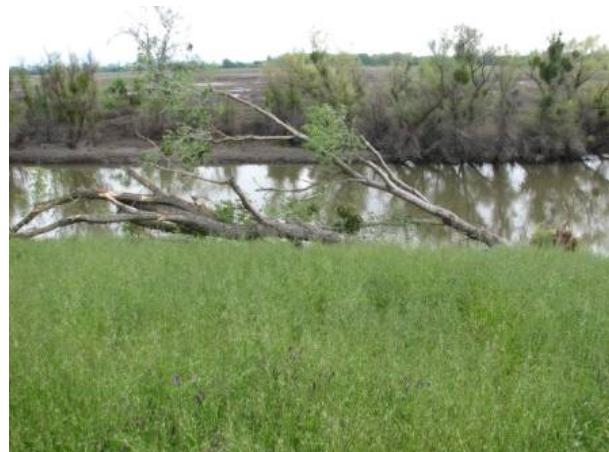
Levee Mile Report Line	6
Start Levee Mile	9.92
End Levee Mile	9.92
Location	Water Side
Category	Earthen Levee
Item	Trim / Thin Trees
A tree has been blown over and the roots have been up rooted. Need to repair the damage area.	
johngw_s_20120313_438.jpg

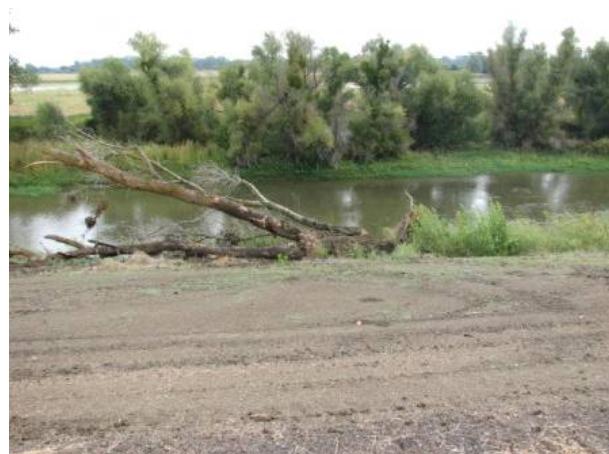
Levee Mile Report Line	6
Start Levee Mile	9.92
End Levee Mile	9.92
Location	Water Side
Category	Earthen Levee
Item	Trim / Thin Trees
The tree needs to be cut up and the rootball area needs to be backfilled. Photo taken fall 2011.	
johngw_s_20120313_439.jpg

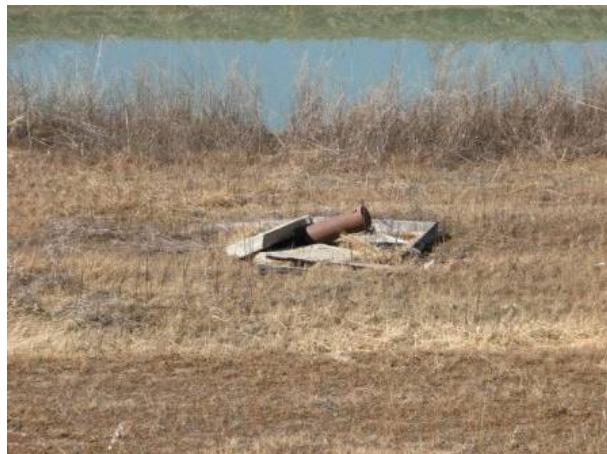
Levee Mile Report Line	9
Start Levee Mile	14.40
End Levee Mile	14.40
Location	Land Side
Category	Earthen Levee
Item	Underseepage Relief Wells
The relief well at boils 14, 15 has been damaged, photo taken spring 2012.	
<i>johngw_s_20120409_651.jpg</i>

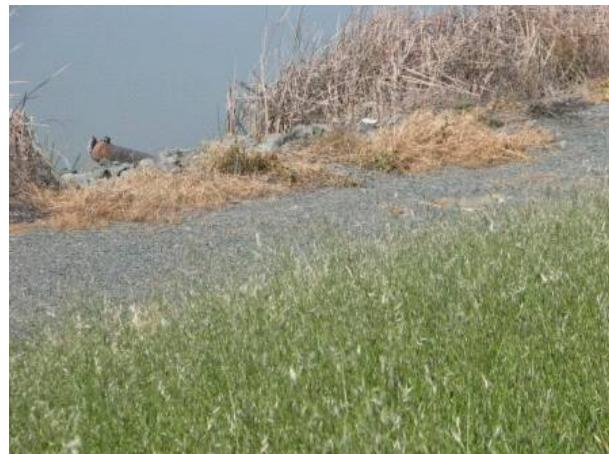
Levee Mile Report Line	12
Start Levee Mile	18.48
End Levee Mile	18.48
Location	Land Side
Category	Earthen Levee
Item	Underseepage Relief Wells
Another toe drainage system close by, photo taken spring 2012.	
johngw_s_20120409_655.jpg
